Montana Power Finds Solution to Woodpecker Problem at Substation

by Rose Lei, Electrical Engineer, Great Falls Division, Montana Power Co.

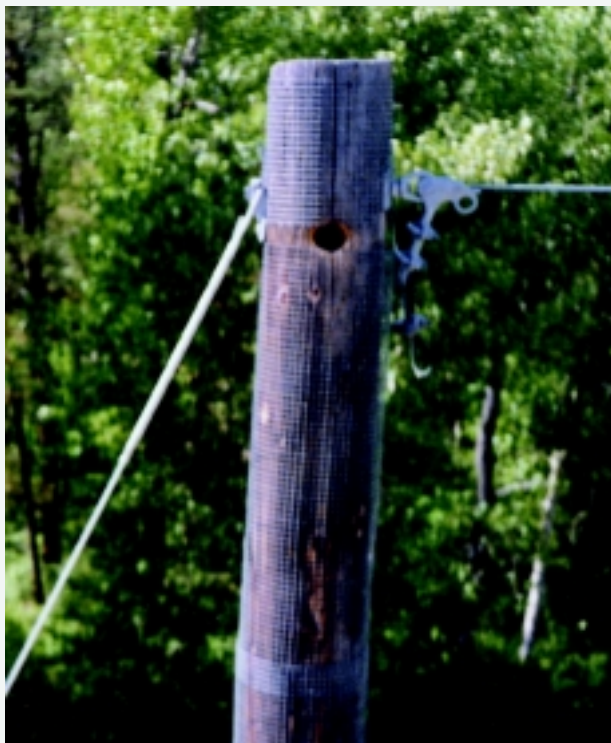
Woodpecker Damaged Round Wood Pole

The game is over at a small substation in the little belt mountains in central Montana. In the past, the wood pole on which the static wire over the substation is dead ended, has been the playing field for woodpeckers against the company. The woodpeckers have succeeded in their damage to this pole and others in the area. Even though, in a final attempt, we wrapped this pole with wire mesh fabric, the woodpeckers still penetrated our defense.

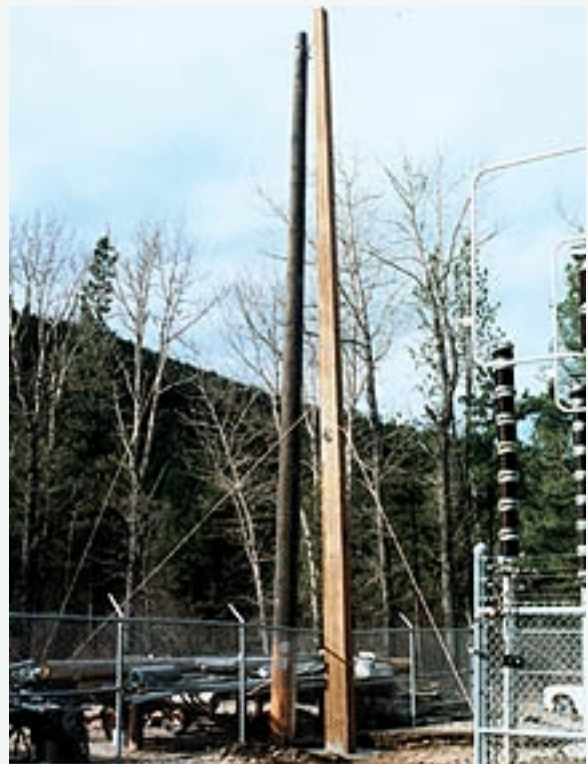
New E-LAM Pole

Then, in November 1994, we set a 52' unguyed, dead end laminated pole from Laminated Wood Systems, Inc. (LWS). Since this pole was one of

Now, after more than 6 years in use, there are no signs of woodpecker damage to the laminate, while others in the area continue to be damaged with every passing season.
